TECHNICAL REPORT SL-81-4

TEST AND ANALYSIS OF UPGRADED ONE-WAY REINFORCED CONCRETE FLOOR SLABS

Mark K. McVay

Structures Laboratory
U. S. Army Engineer Waterways Experiment Station
P. O. Box 631, Vicksburg, Miss. 39180

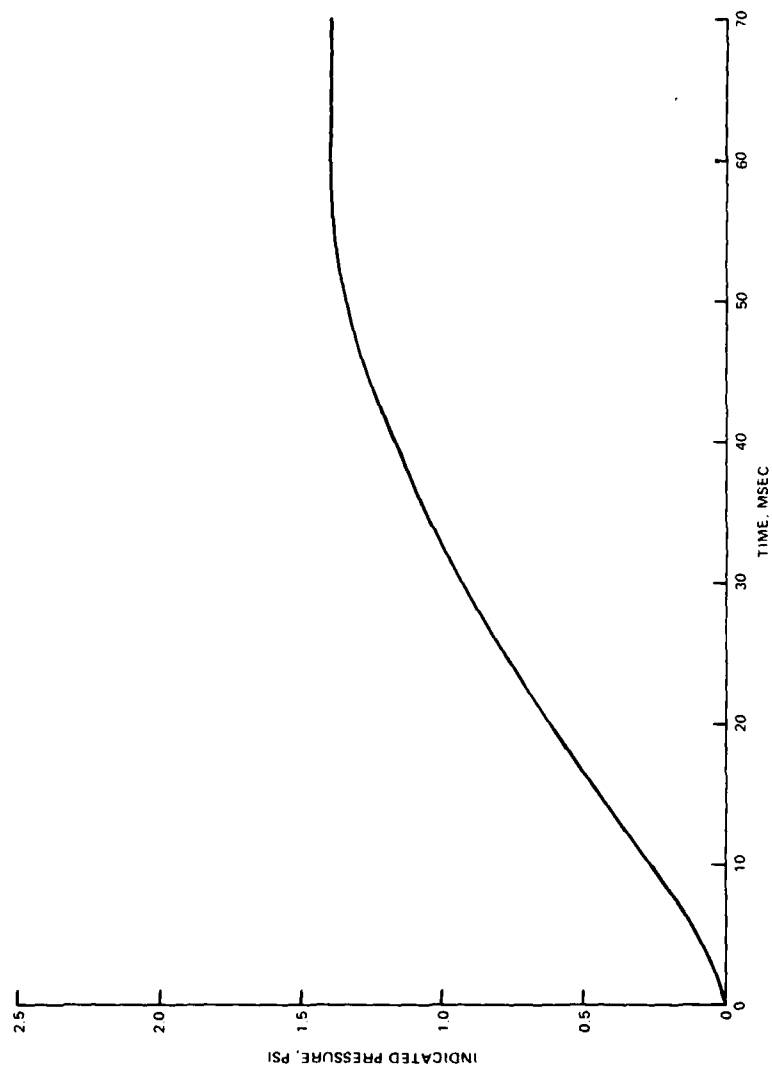
Figure 5.1 Indicated pressure from a moderate temperature increase on a XTMS-1-190-25 airblast gage.

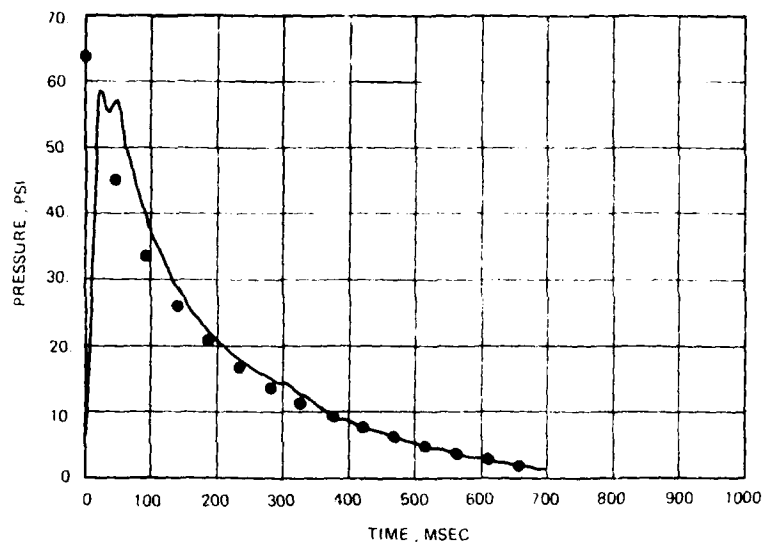
This test applied an average peak overpressure of 63.0 psi, which simulated an overpressure from a 534-KT weapon as shown in Figure 5.40.

Figure 5.40 Weapon fit of shot SLAB 3B.
